# TEST REPORT

Sample name: Notebook  
Model No./ Material: Daten DCM4A-4  
Number of sample: 4pcs  
Sample Received: 2021-03-24  
Testing Period: 2021-03-25

**Test item:** Drop test\*  
**Test standard:** According to client's requirements and refer to the standard MIL-STD-810G Method 516.7/Procedure IV.

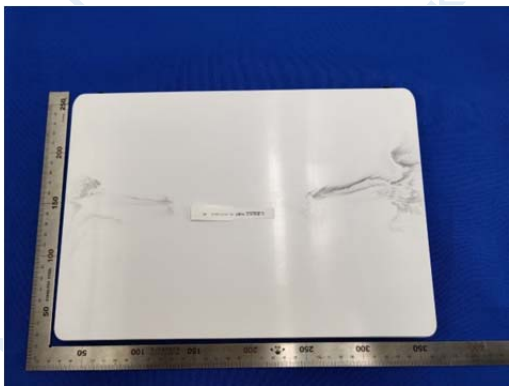
Before test-1 (210324005-001)	Before test-2 (210324005-001)

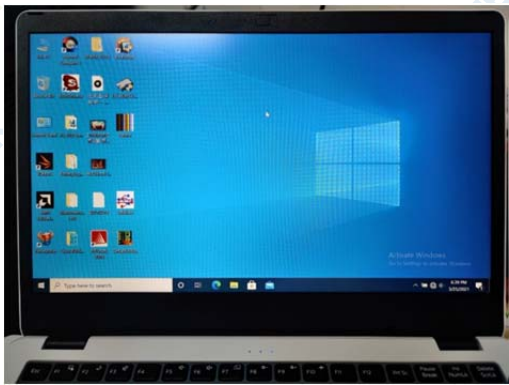
Before test-3 (210324005-001)	Before test-4 (210324005-002)

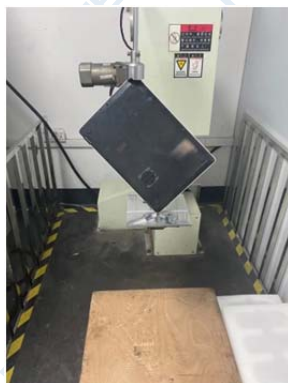
Testing-17 (top corner 3)  
(210324005-002)

- 1) Sample status: shutdown.
- 2) Test position: 8 corners, 12 edges, 6 faces.
- 3) Drop times: 1times/ position.
- 4) Drop height: 76.2cm.
- 5) Floor: wooden floor, thickness: 2in (5.08cm).

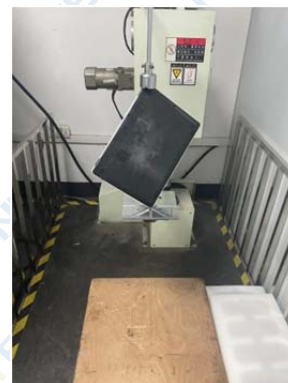
Testing-18 (top corner 4)  
(210324005-002)

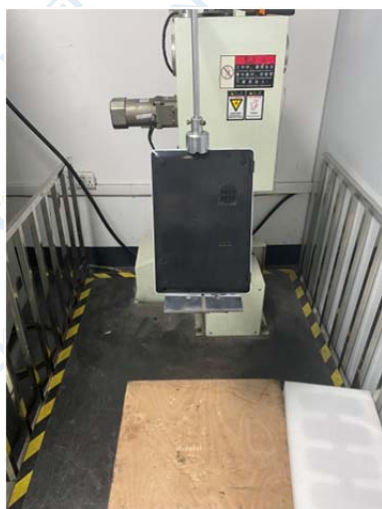
Testing-19 (top edge 1)  
(210324005-003)

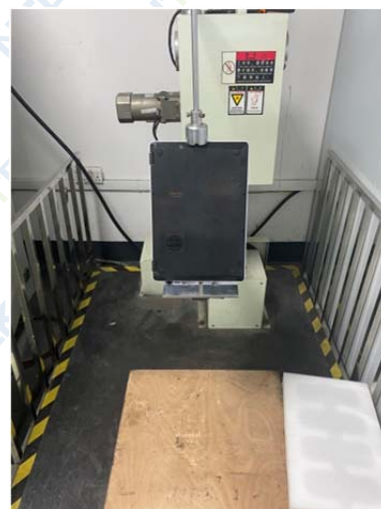
Testing-20 (top edge 2)  
(210324005-003)

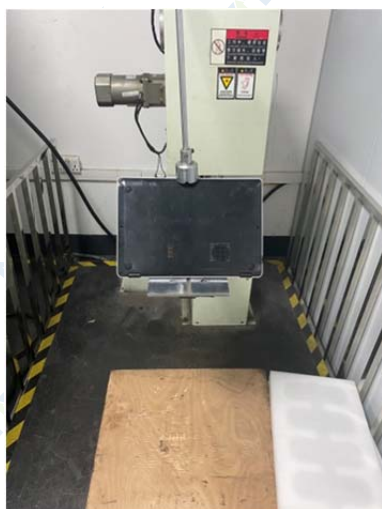
Testing-21 (top edge 3)  
(210324005-003)

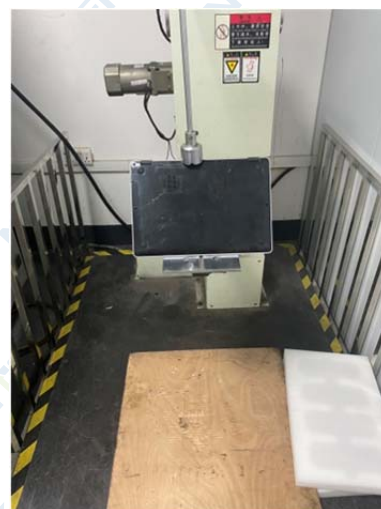
Testing-22 (top edge 4)  
(210324005-003)

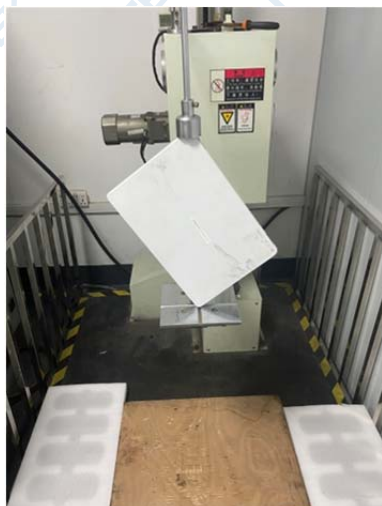
Testing-23 (corner edge 1)  
(210324005-004)

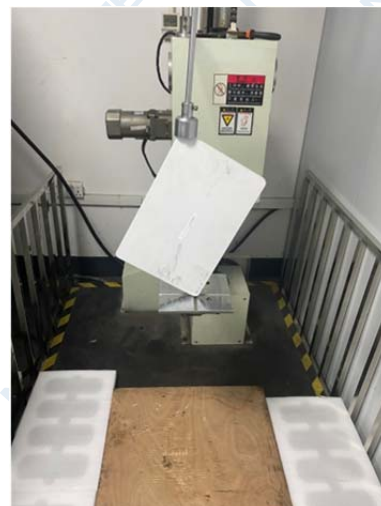
Testing-24 (corner edge 2)  
(210324005-004)

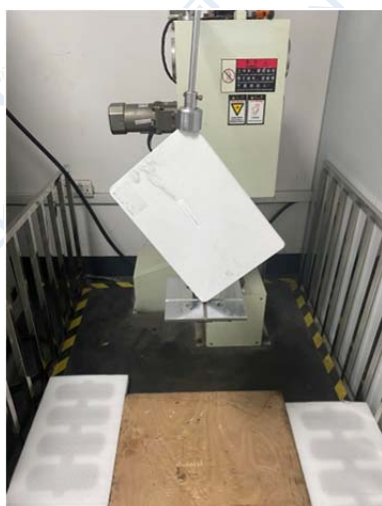
Testing-25 (corner edge 3)  
(210324005-004)

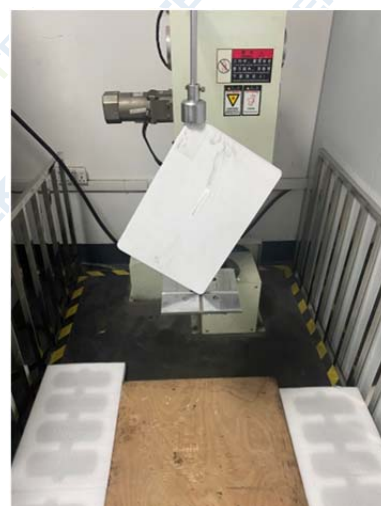
Testing-26 (corner edge 4)  
(210324005-004)

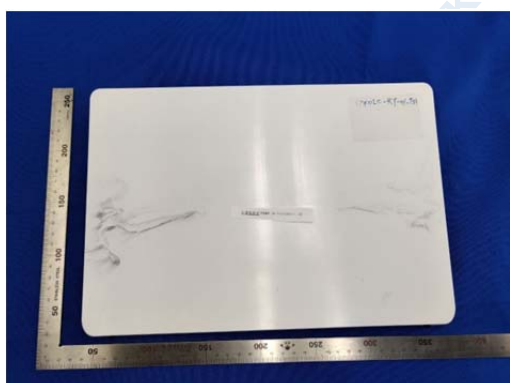
After test-1 (typical photo)

Sample No.	Test result	Criterion	Conclusion
210324005-001 ~004	After the test, the appearance of the sample was not damaged and the system functions normally.	After the test, system function must be OK, mechanical no feature destroyed, no color change or rubber peel off system.	Pass
Note: The criterion provided by the client.

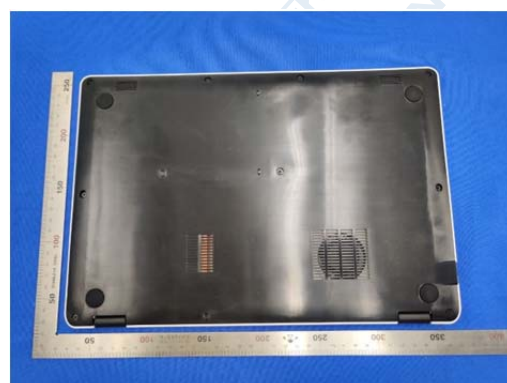
After test-2 (typical photo)
